Solutions Balboa BP Topside Not Working

This is an instructional guide detailing the Fuse that is effected by incorrect supply wiring to the Control Pack. This Fuse controls the Topside and if blown the Topside will not work.

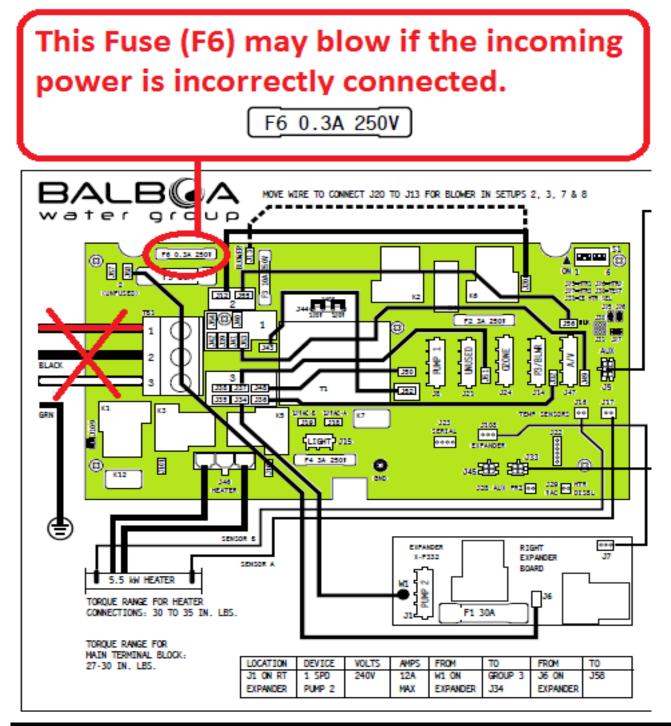
If Red and Black (which is 240V between them) supply feeds are connected to terminal block positions 1 and 2 this may blow the F6 fuse as it feeds 240V to a transformer expecting only 120V. The Topside will remain blank when power is applied to the Control Pack. Correct the wiring and replace the fuse with a 0.3amp 250v fuse.
